Report No. 8926-066

Materials - Finishes and Coatings - Acrylic Paints

Laboratory and Service Evaluations

ACRYLIC PAINT SYSTEM - EVALUATION OF

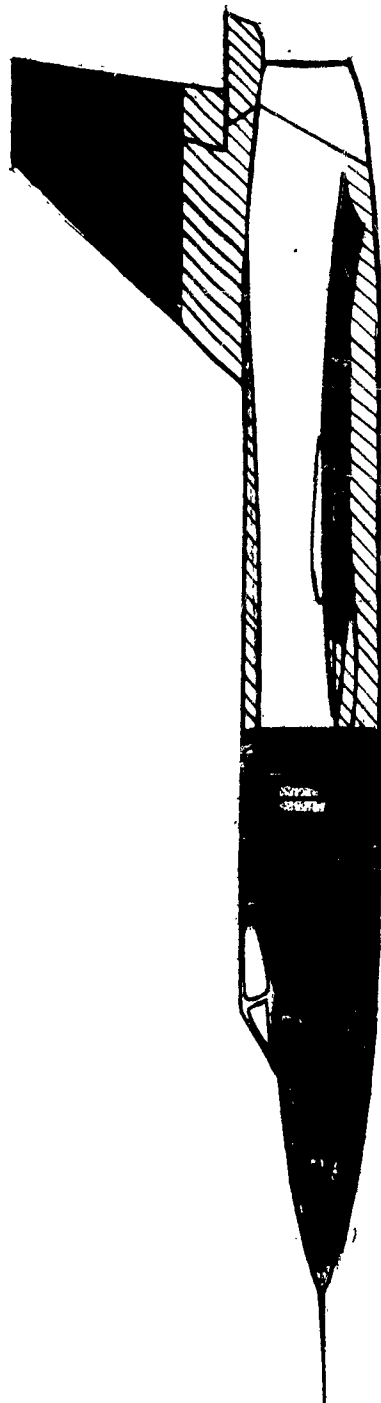
Figure 1.
 Finishing Schedule

LEFT SIDE

Shaded areas represent areas covered by Day-Glo high conspicuity paint. These areas were not included in the test program.

These areas were painted with Mil-C-8514 + Mil-P-8585. They were coated as follows:

Mil-C-8514 + Mil-P-7962 + M49AC10 gray acrylic.

These Areas were stripped to bare metal and coated with P40G1 special wash primer + M49AC10 gray acrylic.

RIGHT SIDE

On 10 April 1958, F-106A aircraft No. 60456 was painted in the Experimental Factory with the Sherwin Williams acrylic system. This ship had been painted with Mil-C-8514 wash prime and Mil-P-8585 zinc chromate prime prior to arrival in the Experimental Factory. This condition was representative of what would be encountered in production during a changeover from the present finish system. Where it was necessary to apply the Sherwin Williams acrylic over the aged Mil-P-8585, the following procedure was used:

- a) A light coat of Mil-C-8514 wash prime was applied over the Mil-P-8585.
- b) A cross coat of Mil-P-7962 lacquer type zinc chromate prime was applied over the Mil-C-8514.
- c) The Sherwin Williams M49AC10 gray acrylic, thinned 1 part M49AC10 to 2 parts of R7KG235 thinner, was applied over the Mil-P-7962.

Several areas on the fuselage were stripped down to the bare metal and primed with the Sherwin Williams P4OGC1 wash primer, mixed per the manufacturers instructions, and top coated with the M49AC10 acrylic. One of these areas was the detachable tail cone, which was cleaned and sprayed by Engineering Test Laboratory personnel under the direction of the Sherwin Williams Sales Representative, Mr. Howard Hinig.

Diagrams of the finish schedule applied to ship no. 50456 are shown in Figures 1 and 2.
